*International Technical Meeting  
on “Seismic Safety of NPPs”*

*Tivoli (Roma) - Italy March 25-26, 2010*

# Seismic safety requirements for NPP and experience feedback in Japan

***Yoshi. FUKUSHIMA***

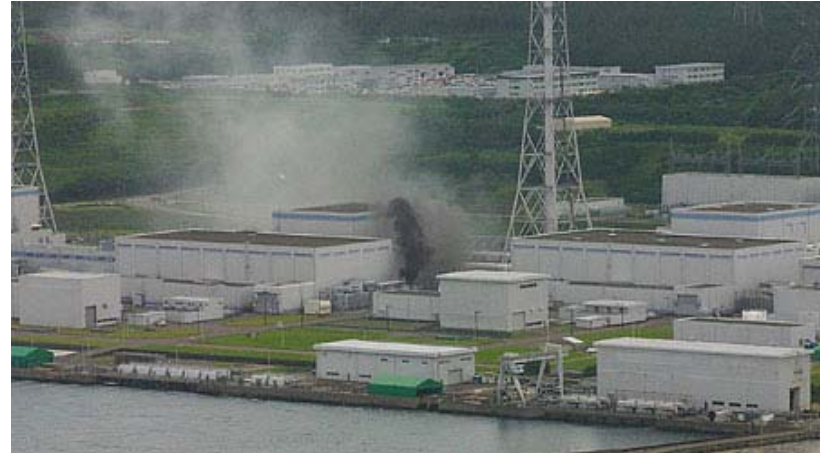
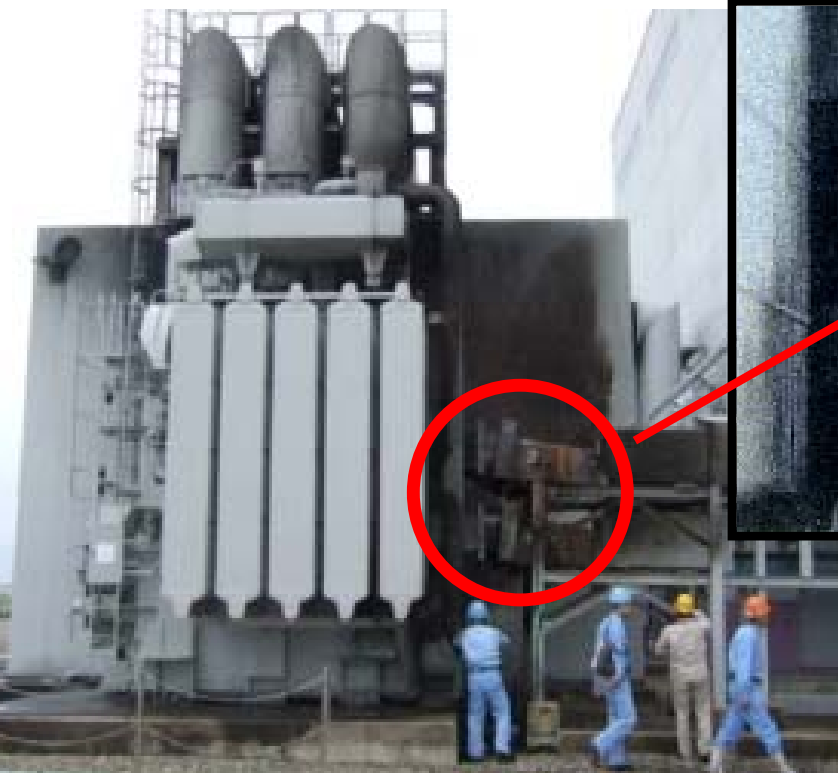
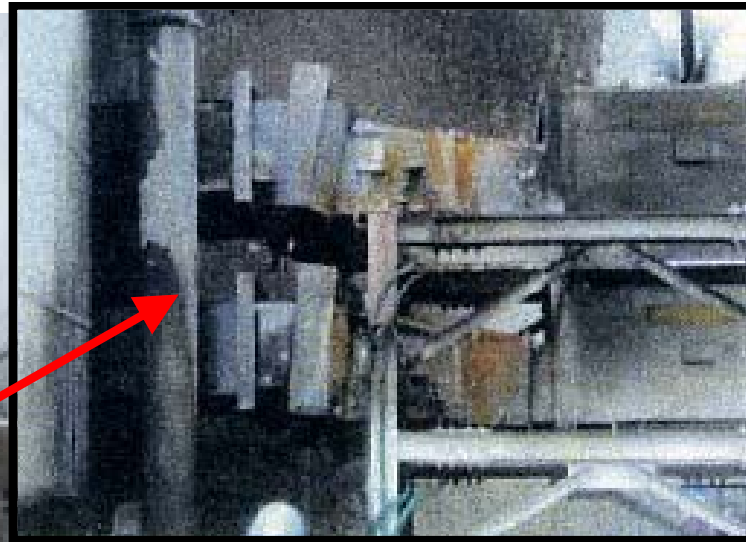
# Fire of transformer at unit 3

- Part : joint part
- Failure mode : bending by soil behavior

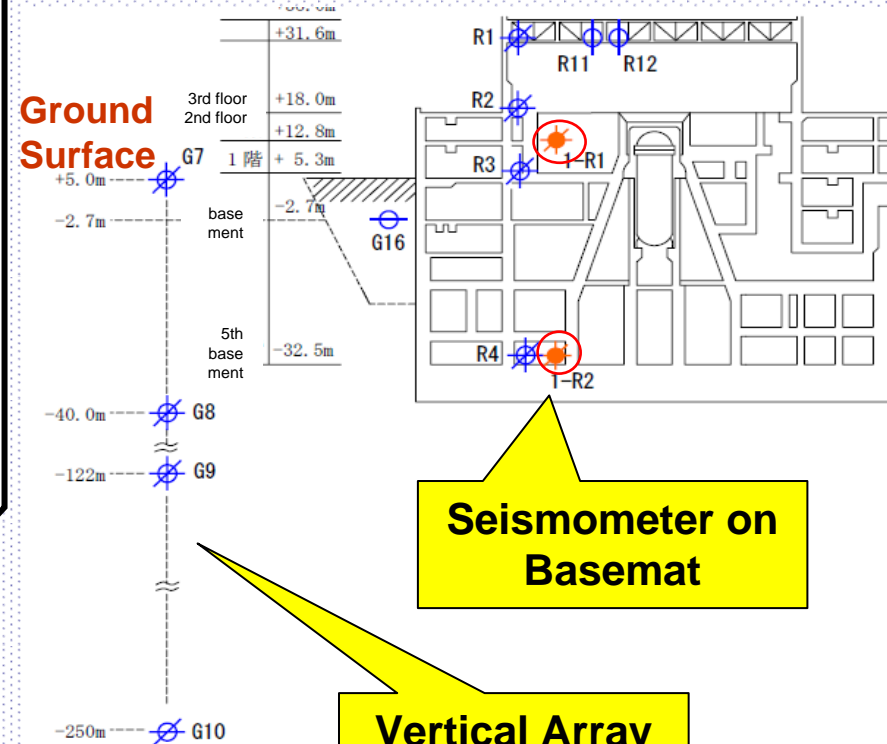
## Earthquake Motion observation at Reactor Building of Unit 1

Most of records were disappeared due to over flow with many aftershocks

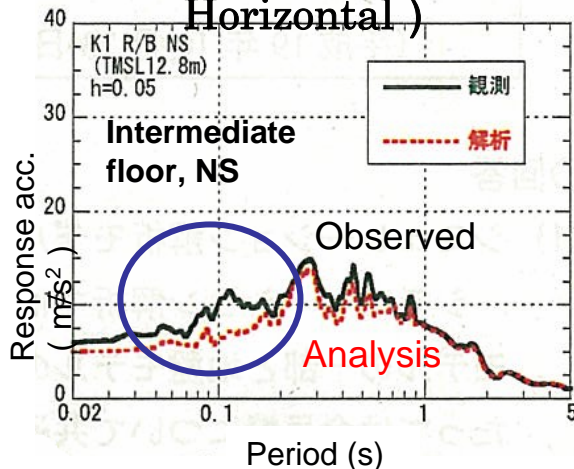
### Point 1

( Unit 1 :  
Horizontal )

**Observed > Analyzed  
at around 0.1 ~ 0.3 s**

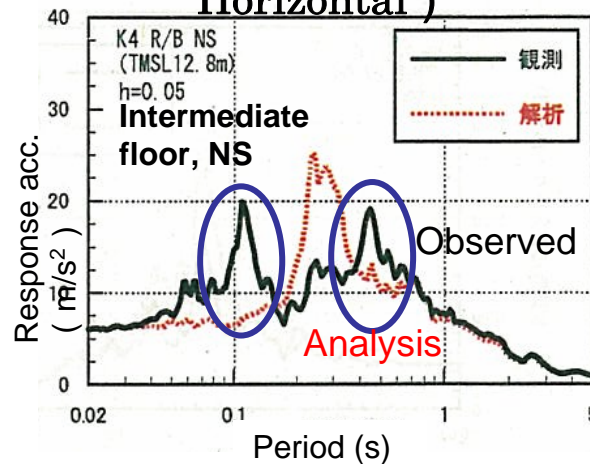
### Point 2

( Unit 4 :  
Horizontal )

**Observed : 2 peaks  
Analysis : 1 peak at 0.3**

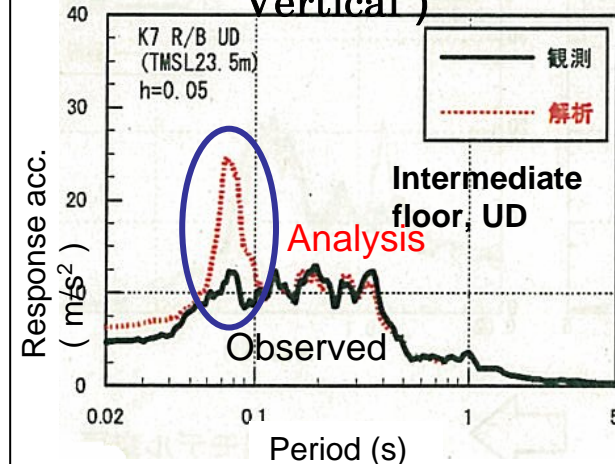
### Point 3

( Unit 7 :  
Vertical )

**Observed < Analysis  
at around 0.09 s**

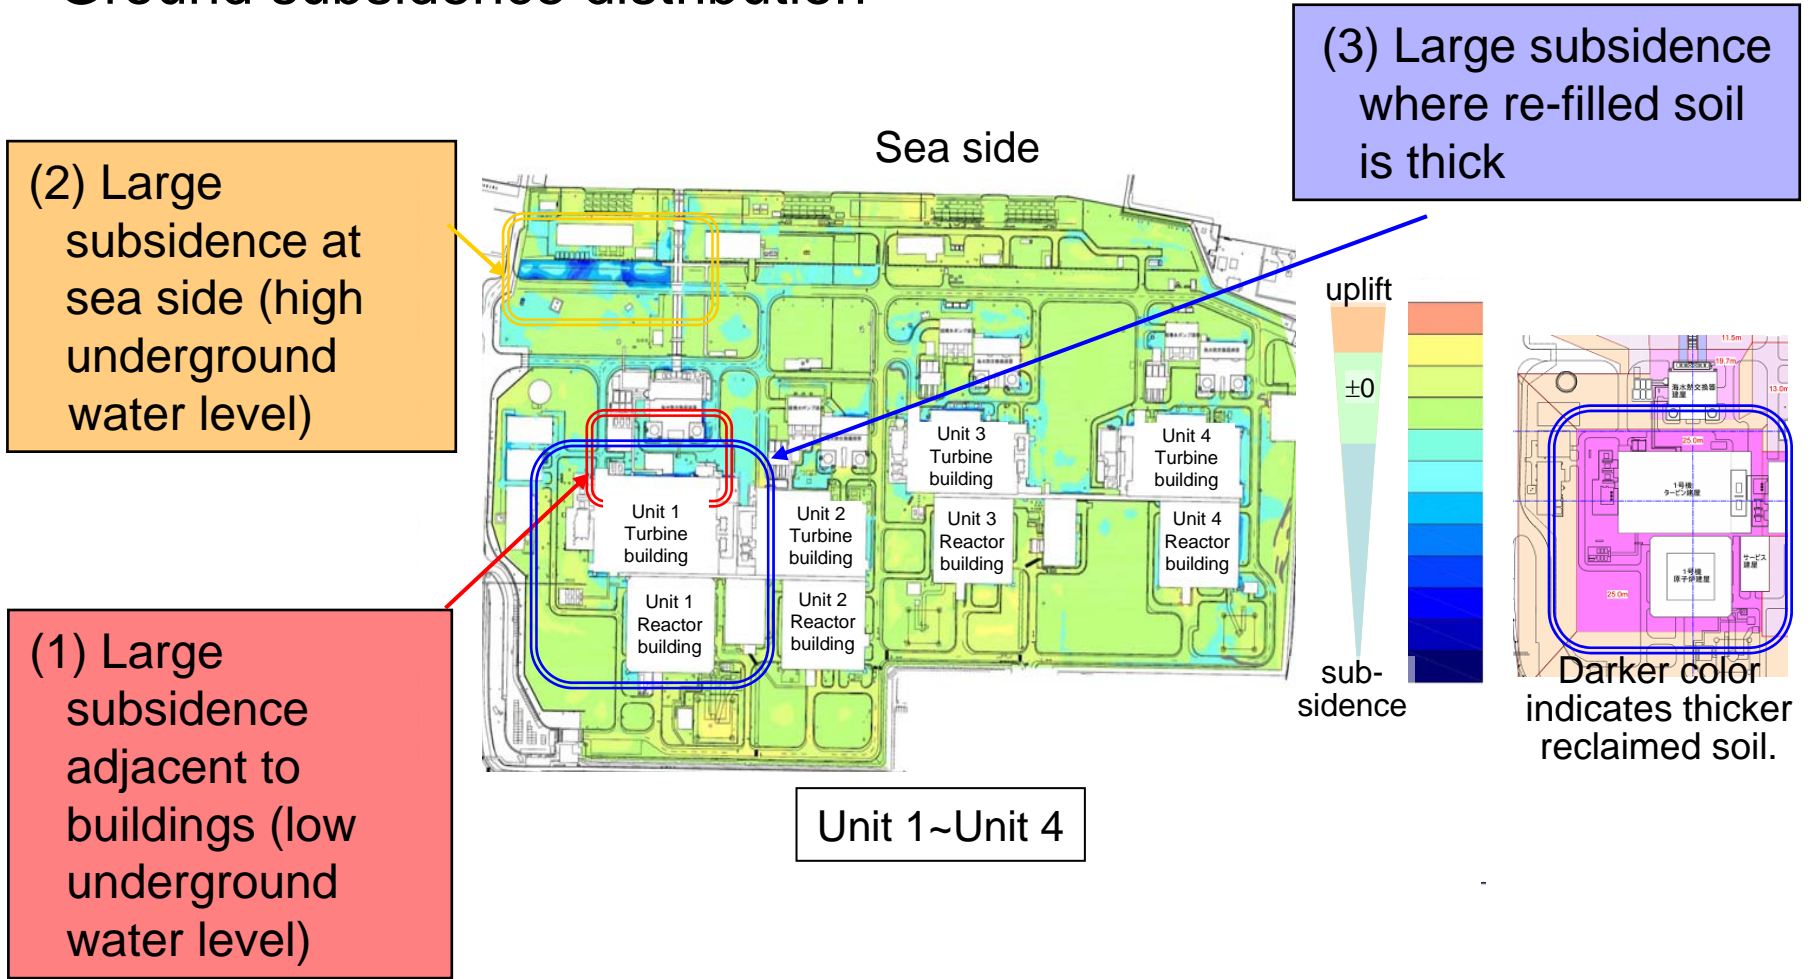
## Ground subsidence distribution

# Ground Deformation (TEPCO, December 25, 2007)

Gradient of the building can be judged sufficiently low compared with the subsidence limit level based on “Recommendation for the Design of Building Foundations” revised in 2001 (Architectural Institute of Japan).
