Fukushima Daiichi Nuclear Accident First considerations

Preliminary Report

May 2011

Fukushima Daiichi Nuclear Accident Preliminary Report

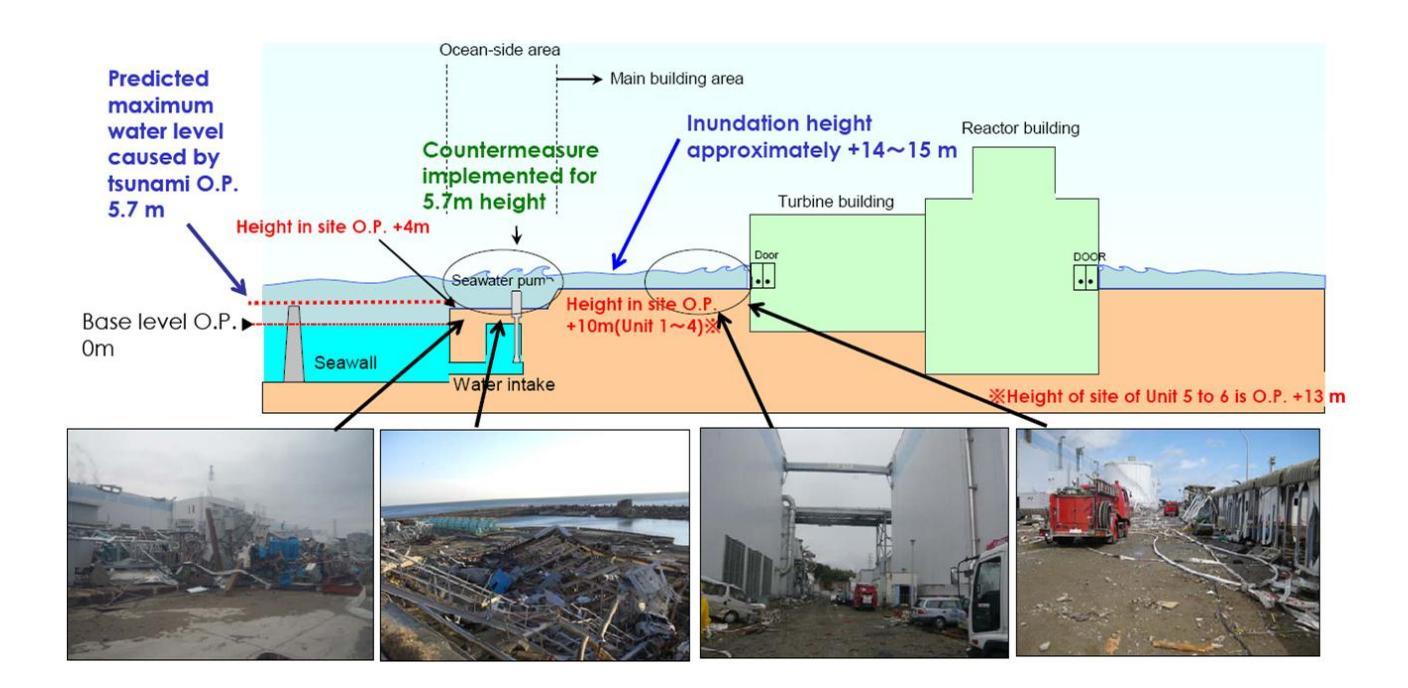
In this regard the figure below (from Tepco on date 2011, April 9th) shows the survey of the tsunami effects at Fukushima-Daiichi:

The design tsunami height was about 6 meters above the sea level while the tsunami following the earthquake was around 14-15 meters high; the resulting inundation depth was around 4-5 meters in most of the main building and ocean-side areas, including the outdoor seawater pumps.

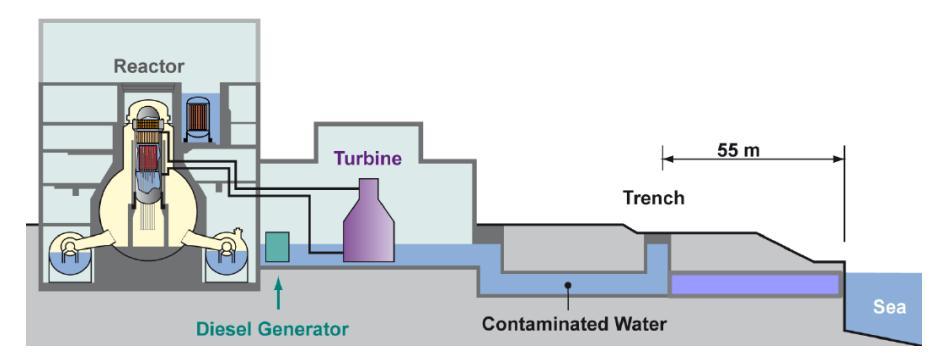
In between April 1 and 6 some 520 m³ of contaminated water from unit 2 (via trenches) with 4.7 PBq of activity leaked into the sea until the source was sealed.

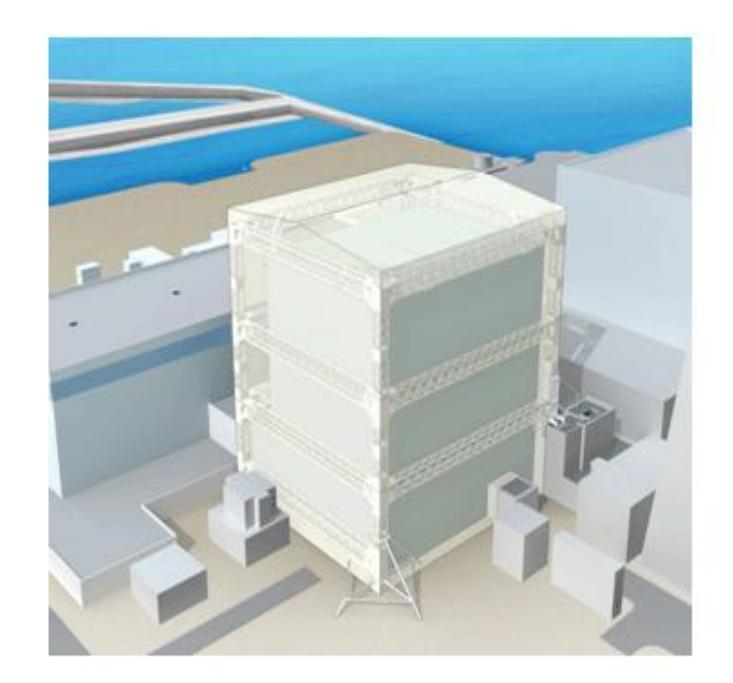
Image of the cover for the reactor building of Unit 1, Fukushima Daiichi Nuc. Power Station

release - Dust-suppressing polymer resin will continue to be applied, and debris removed to improve working conditions on site. A light temporary structure (see fig. aside) will then be built over reactor buildings 1, 3 & 4, followed by a more substantial structure.
