Fukushima Daiichi Nuclear Accident First considerations

Preliminary Report

May 2011

Fukushima Daiichi Nuclear Accident Preliminary Report

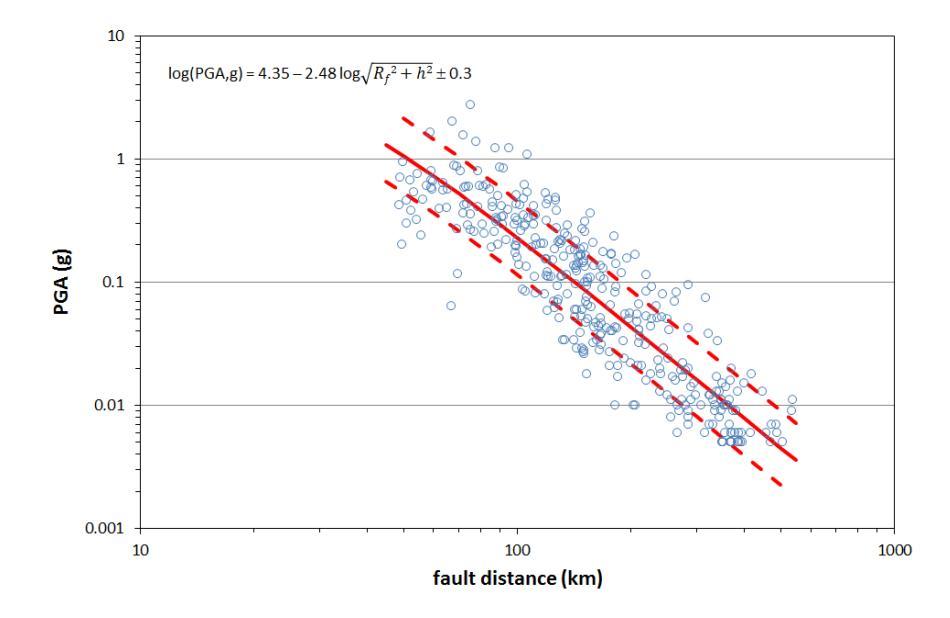
the records. Moreover, they did attenuate rapidly with distance from the causative fault as shown in the figure below, where the red lines display the median and variance of PGA as a function of fault distance for the main shock.

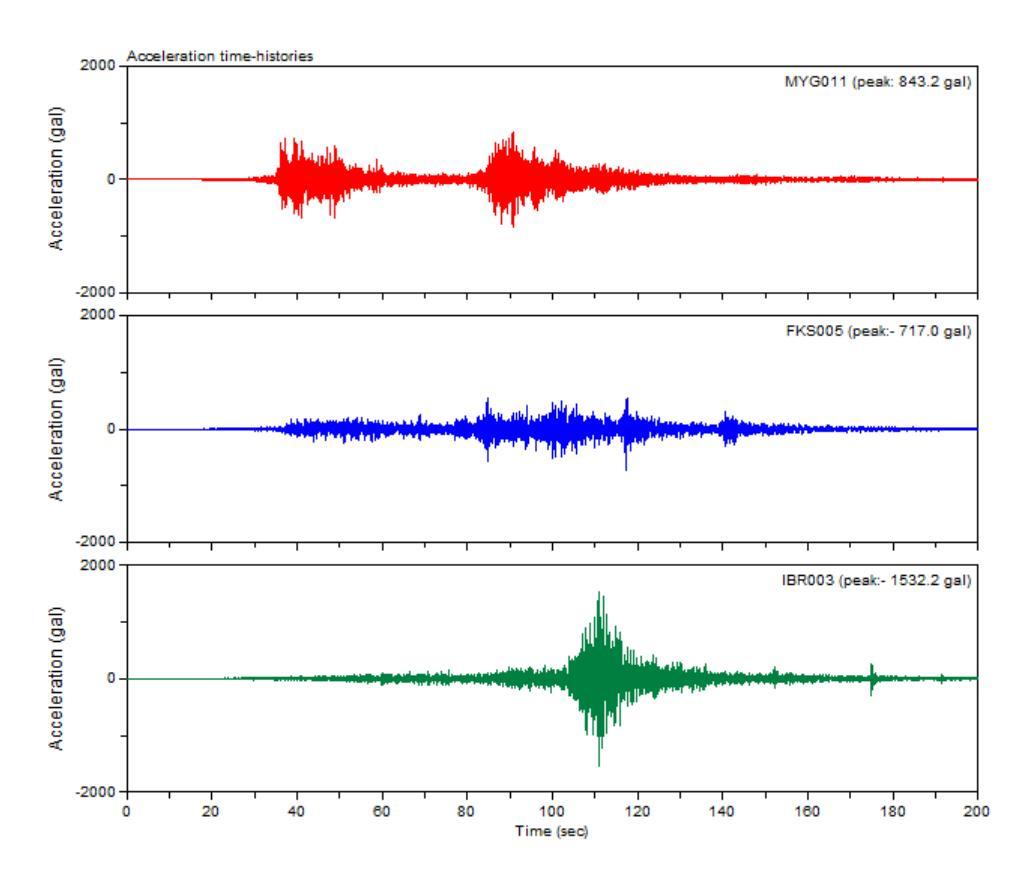
The records selected to represent the most feasible shaking experienced by the NPPs are MYG011, 11 km away from Onagawa NPP, FKS005, 16 km away from Fukushima NPP, and IBR003, 14 km away from Tokai NPP. The ground motion values recorded by the seismic stations in free-field conditions are reported in the table below along with the design values of the NPPs. The figures below show the recorded time-histories and spectra from which the following comments arise:

1. The waveforms show a very complex pattern of the fault rupture, with several and different slip areas from north to south: northward (MYG011) two main and very distinct seismic phases corresponding to as many wide slip areas are clearly visible, which southward reduces to one alone (IBR003) due to the disappearance of the first phase; in the middle both but less distinct phases are still visible with the second one becoming predominant. IBR003 experienced the largest PGA, exceeding 1g, while FKS005 experienced the smallest one but anyway exceeding 0.7g; peak velocities and displacements exceeded 50 cm/s and 10 cm, respectively. Damage-related ground motion parameters were always very high, with Arias intensity values exceeding 20 m/s and cumulative absolute velocities around 9 g*sec, making this shaking one of the strongest ever recorded.

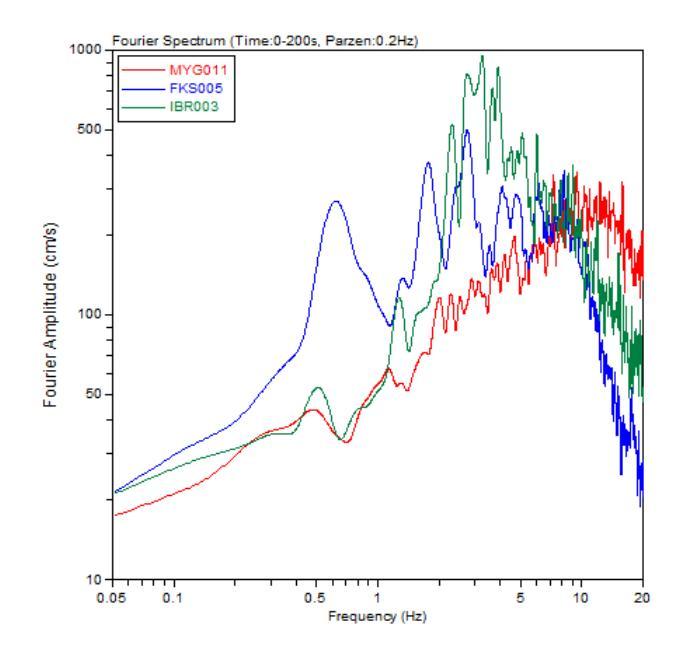
2. MYG011 and FKS005 show a spectral content extending over a large frequency range (between 0.5 and 10 Hz), with the latter exceeding the former in absolute values. IBR003 reaches the highest spectral values but in a narrower spectral range, around 2-3 Hz.

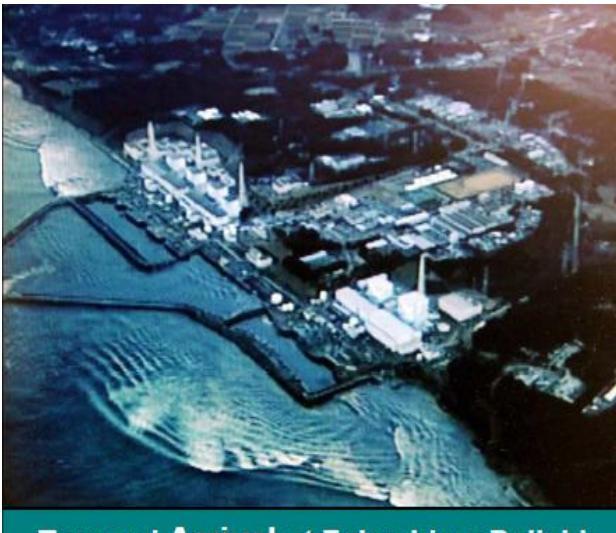
Tsunami Arrival at Fukushima Daiichi

About one hour after the quake (15.41) the onsite electrical emergency power was lost due to the tsunami (14 m wave high) that destroyed the sea water intakes and overwhelmed the plants' physical structures, causing inundation, wetting of many components and making many areas inaccessible.

At 15.42 there was a total blackout due to loss of all D/Gs induced by the damages produced by the tsupami
The exact time interval between the arrival of the tsunami and the loss of each
D/G, the failure mode of the D/Gs and differences need to be investigated.
We know that the tsunami destroyed the sea water intakes to the NPP and overwhelmed the plants' physical structures, causing inundation, wetting of many components, making many areas inaccessible during the inundation and thus making further operations impossible during that time.
The internal flooding of the lower parts of the building on the site appears to happened also through the connecting underground trenches which were exposed to tsunami wave (see the cause of the death, happened on March 11 soon after the tsunami and discovered on March 30, of two workers in the basement of turbine of unit 4).
The resulting accident event was a " total station blackout " for units 1, 2, 3 and 4: in fact 12 of 13 back-up diesel generators (D/G) on site, located in the basements of the turbine buildings, were disabled. The electrical switchgears underground or at ground floor were also disabled.

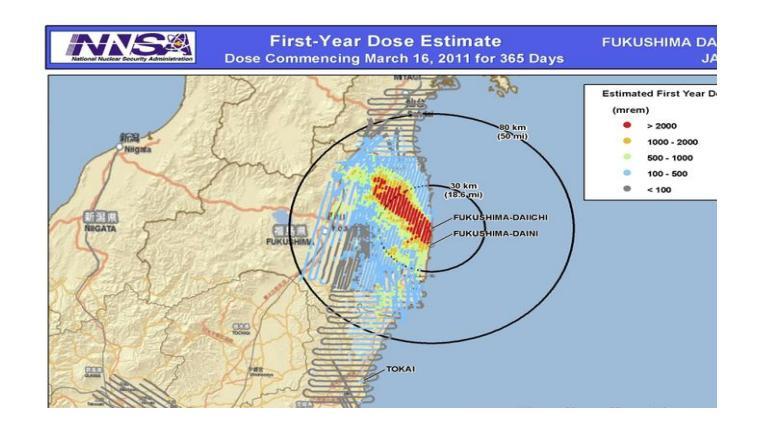
The results are described by dose maps as shown in the figure aside. It appears that the doses are no more in the range of "low doses" according to UNSCEAR definition (United Nations Scientific Committee on the Effects of

Atomic Radiation). The French report (ref. /28/) shows significant values of projected doses some above 200 mSv in the north-west fallout sector and even beyond the 20 km evacuation zone. These dose values do not consider the doses received during the accident (plume immersion, inhalation of particles) or to be received from internal contamination and ingestion of contaminated foodstuff. The total estimated projected effective doses could be much higher. The number of Japanese people living in the most contaminated area outside the 20 km evacuation zone is estimated to be 70.000 including 9.500 children between 0-14 years.
